**FINAL REPORT
ROUND 7 DAM ASSESSMENT - WISCONSIN POWER & LIGHT
COLUMBIA GENERATING STATION
PRIMARY ASH, SECONDARY ASH, POLISHING & LANDFILL
STORMWATER PONDS
PARDEEVILLE, WISCONSIN**

June 2, 2011

Re: Round 7 Dam Assessment - Final Report
EPA Contract No. EP10W001313
Wisconsin Power & Light – Columbia Generating Station
Primary Ash, Secondary Ash, Polishing & Landfill Storm Water Ponds
Pardeeville, Wisconsin

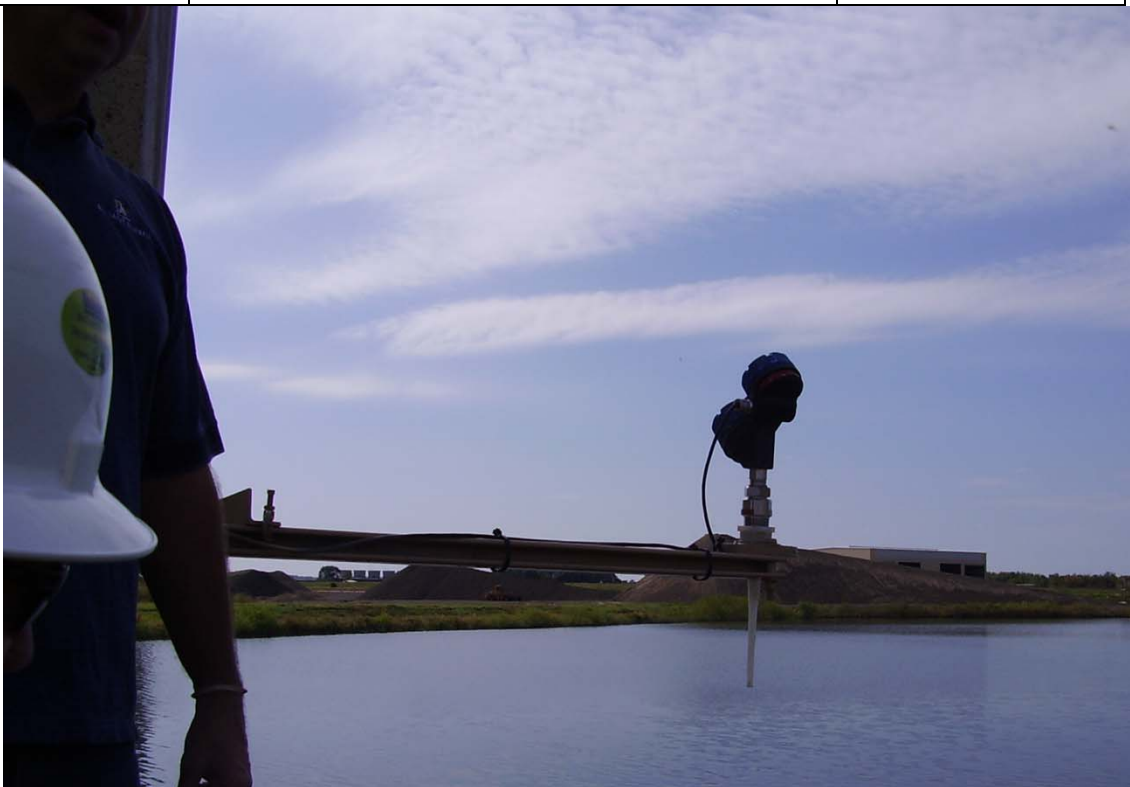
Electronic Water Level
monitor on the PAP Pump
house.

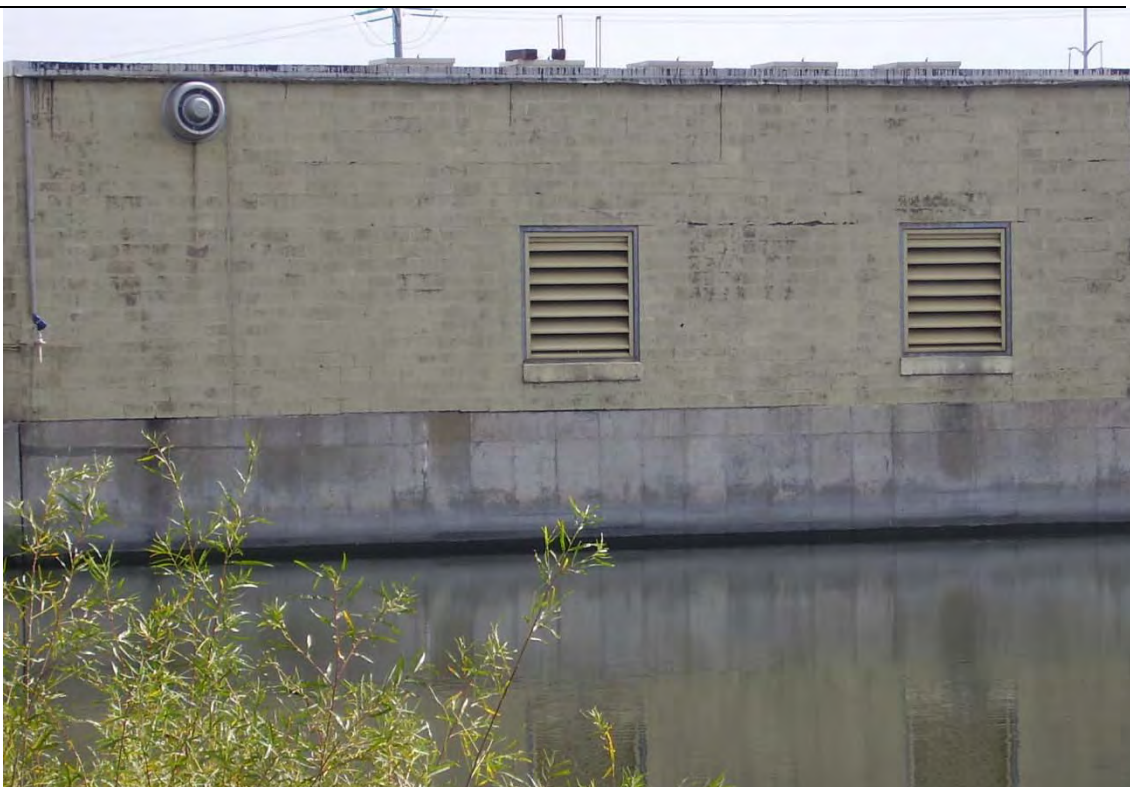
Photo No.
88

PAP pump house.

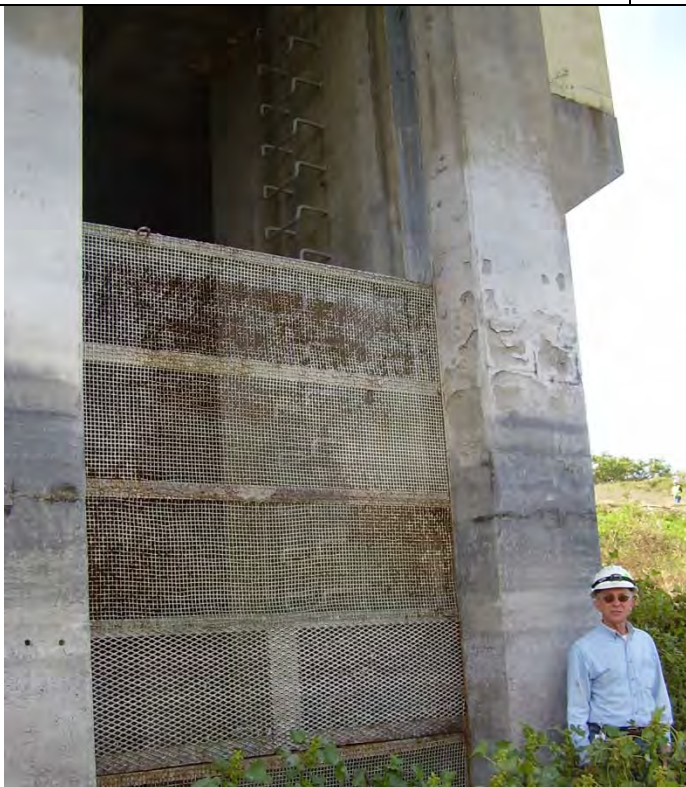
Description:
SAP pump house intake.

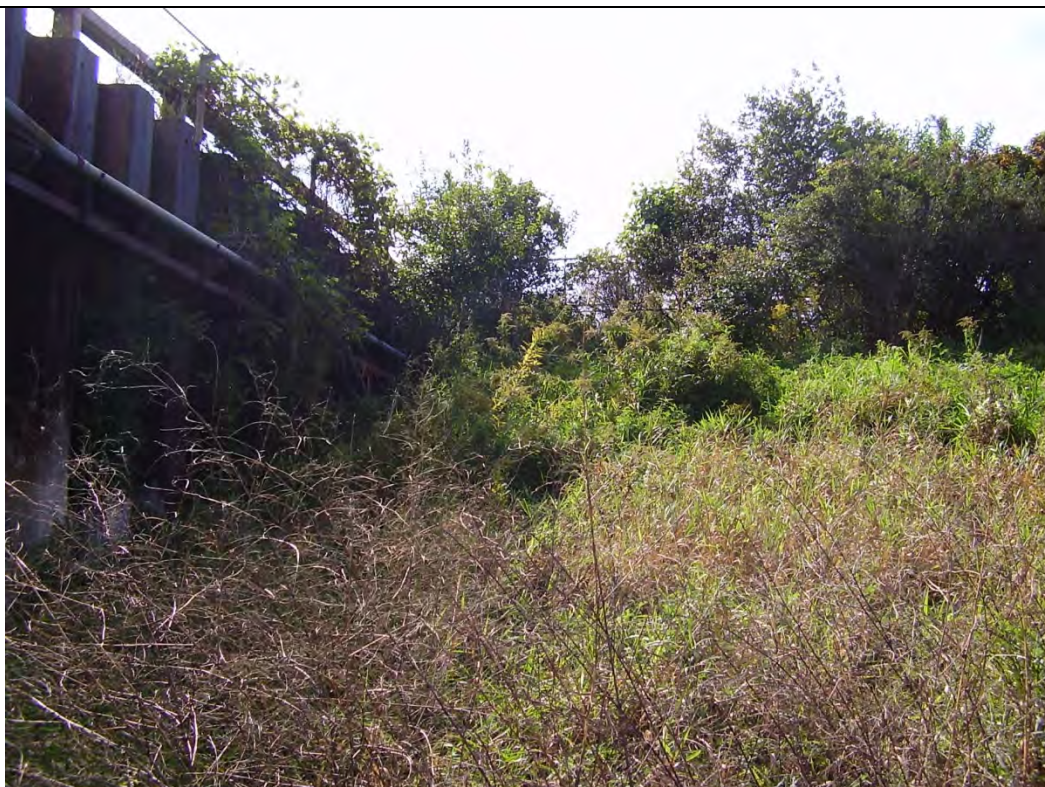
Photo No.
90

Description:
SAP pump house.

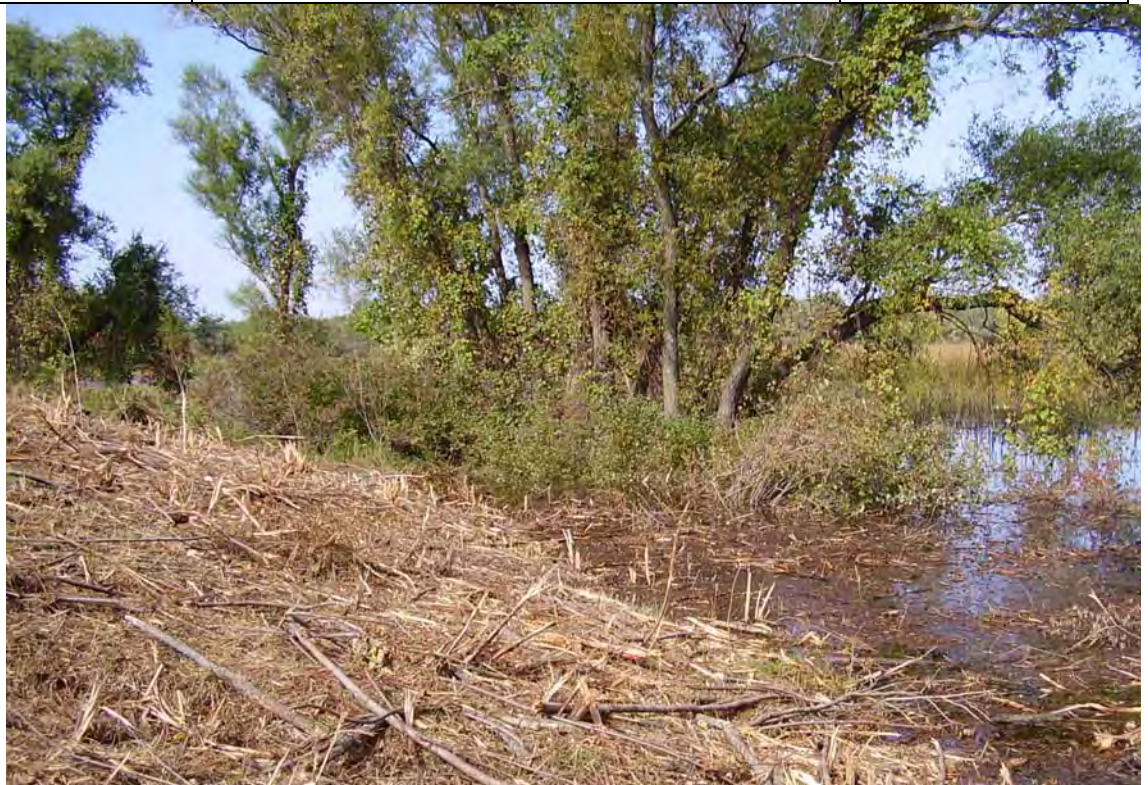
Description:
SAP downstream slope.

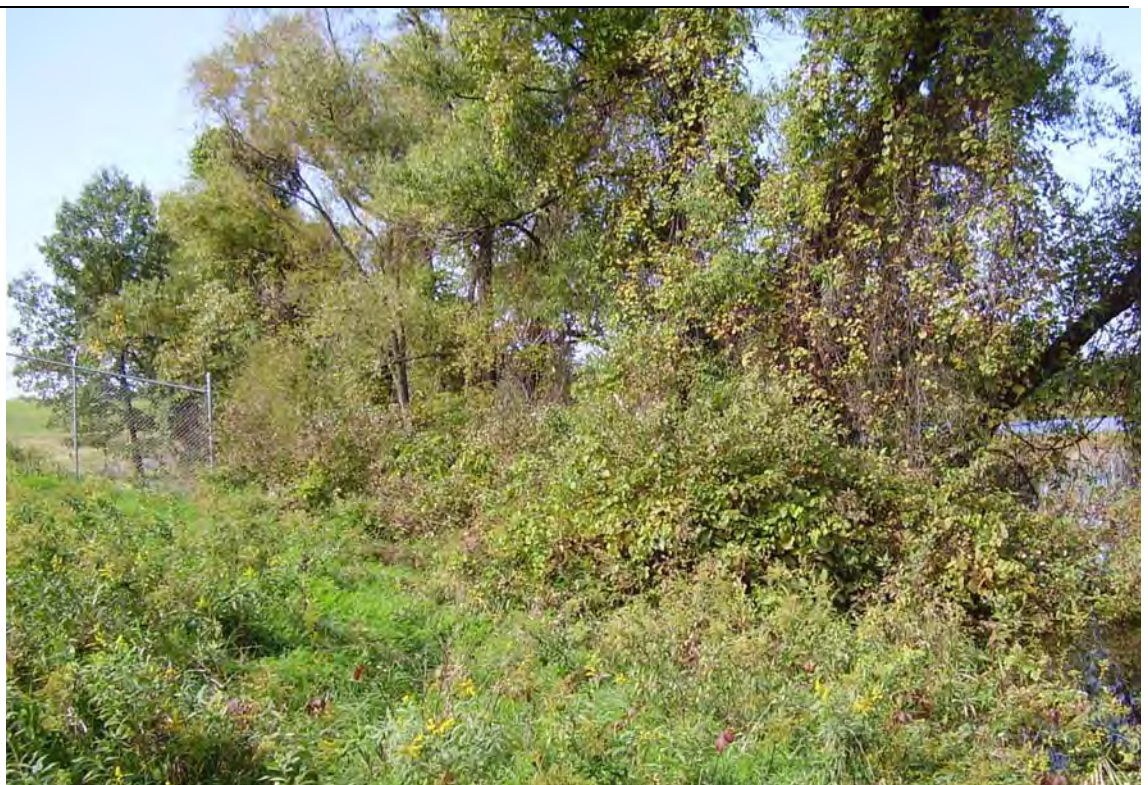
Photo No.
94

Description:
SAP downstream slope.

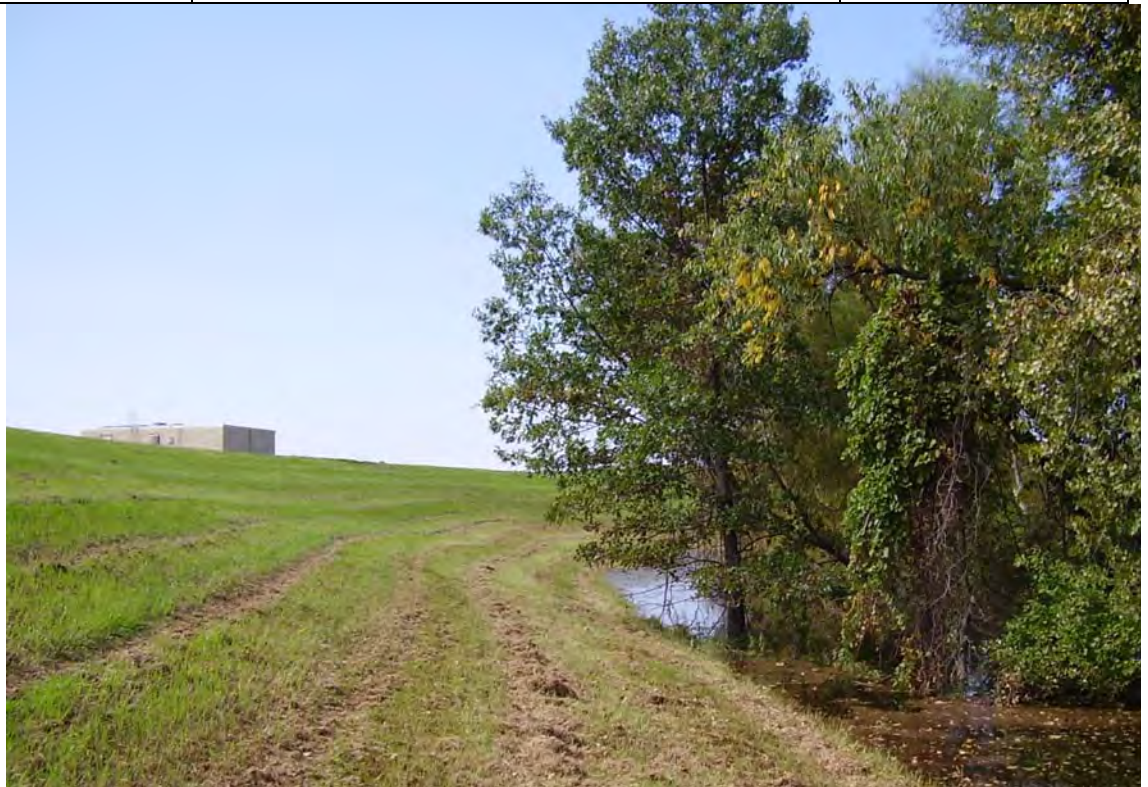
Description:
SAP downstream slope.
